Carter's conundrum

The tale of another unusual dead-end S&D working.
Compiled by **Peter Russell**

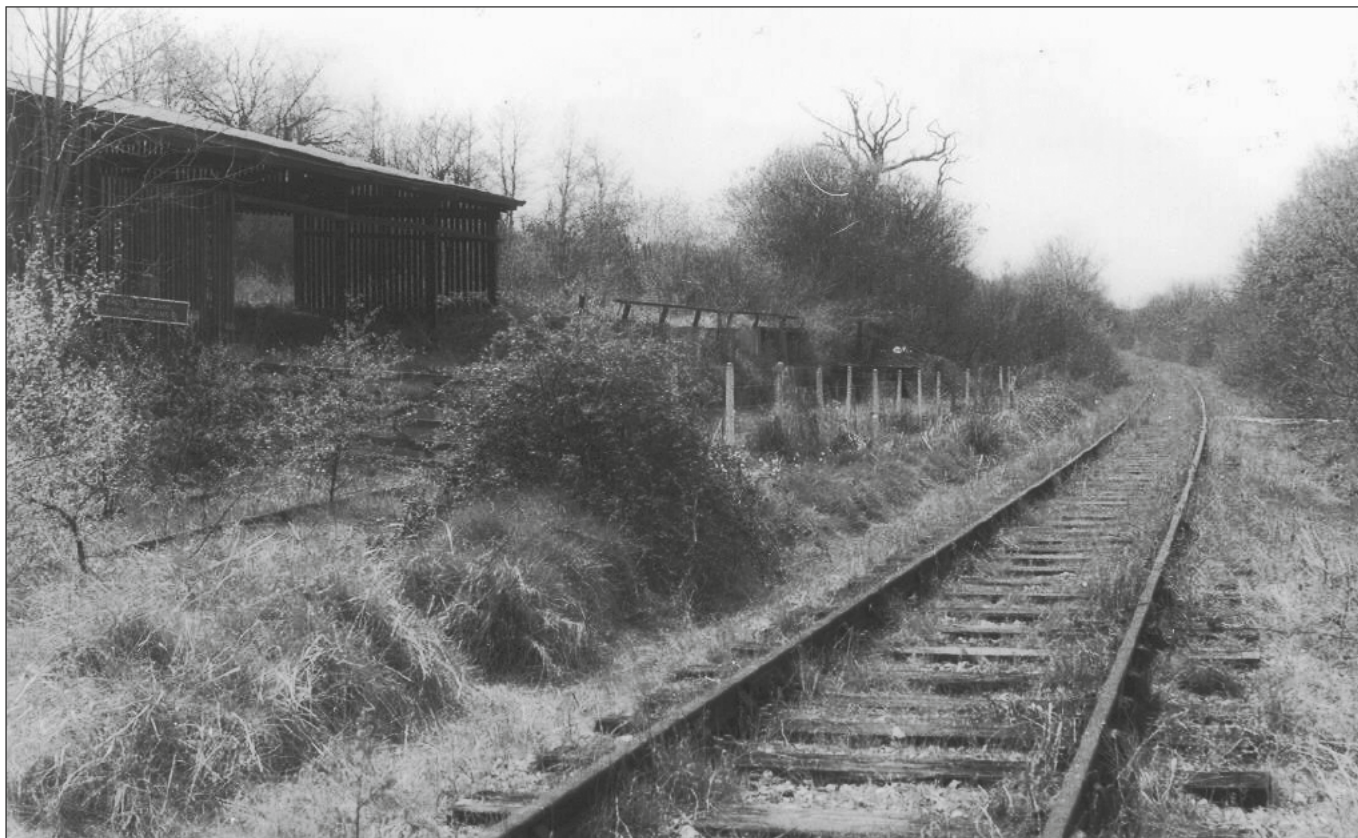
Carter's Siding (left), looking south west along the remains of the S&D's Wimborne loop towards Corfe Mullen Junction, 24th April 1965. Note the transshipment shed, loading dock and entrance gate with notice saying: 'ENGINES MUST NOT PASS THIS BOARD'. *Colin Caddy*

4. The guard set the road (by this time there was just a lever on the point, not a ground frame) and the loco backed the empties into the siding. (Author's note: beside the gate across the siding was a red wooden board with white lettering stating: "ENGINES MUST NOT PASS THIS NOTICE BOARD".)

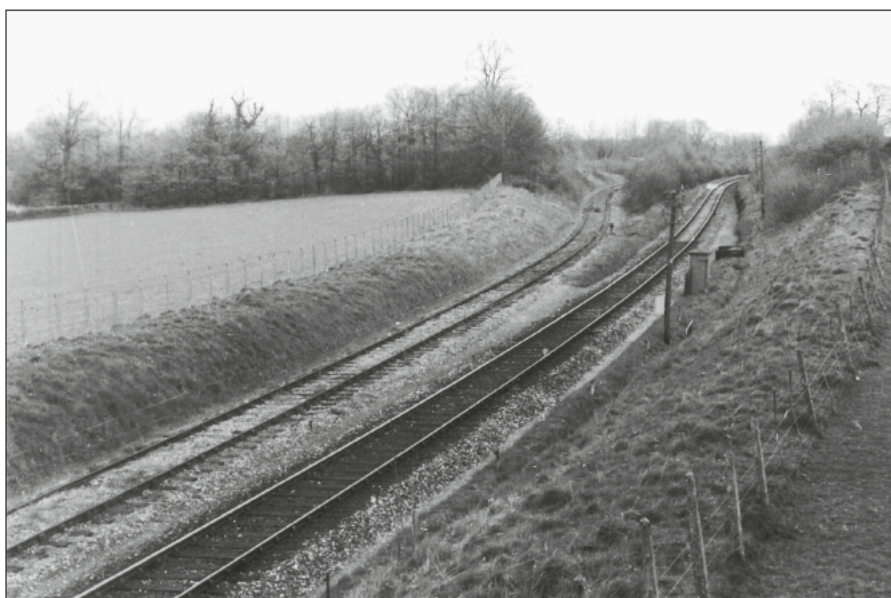
The divergence of the Wimborne line (left) and Broadstone line, looking east from Corfe Mullen Junction Bridge, 24th April 1965. The goods train serving Carter's Siding would have initially pulled up on this section of the Wimborne loop clear of the junction and ground signal, before uncoupling the portion to be shunted to the siding. *Colin Caddy*

1. The train moved across Corfe Mullen Junction and ran forward onto the truncated Wimborne line far enough to clear the dummy that protected the exit.

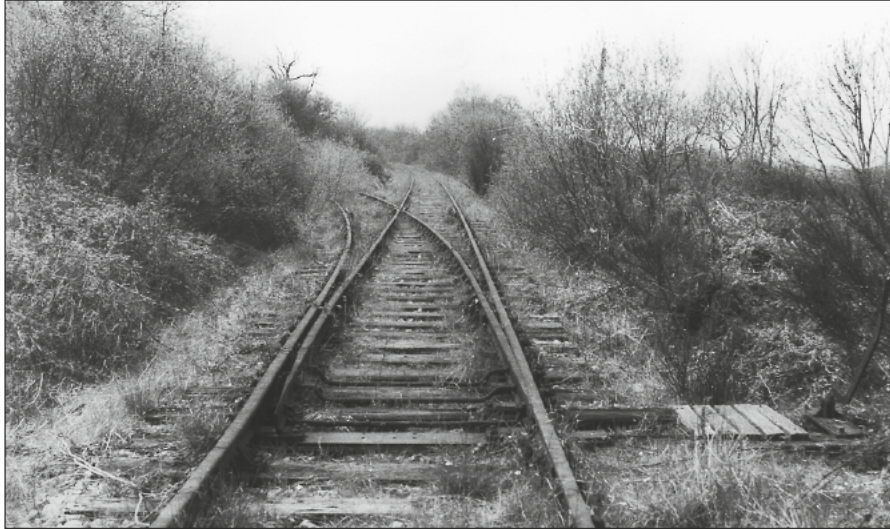
The lead into Carter's Siding (left) from the erstwhile Wimborne loop, looking south west, 24th April 1965. A former ground frame had been replaced in the 1930s by the single point lever (right foreground). The headshunt continued for about four chains behind the camera. Nature is quickly reclaiming its own. *Colin Caddy*

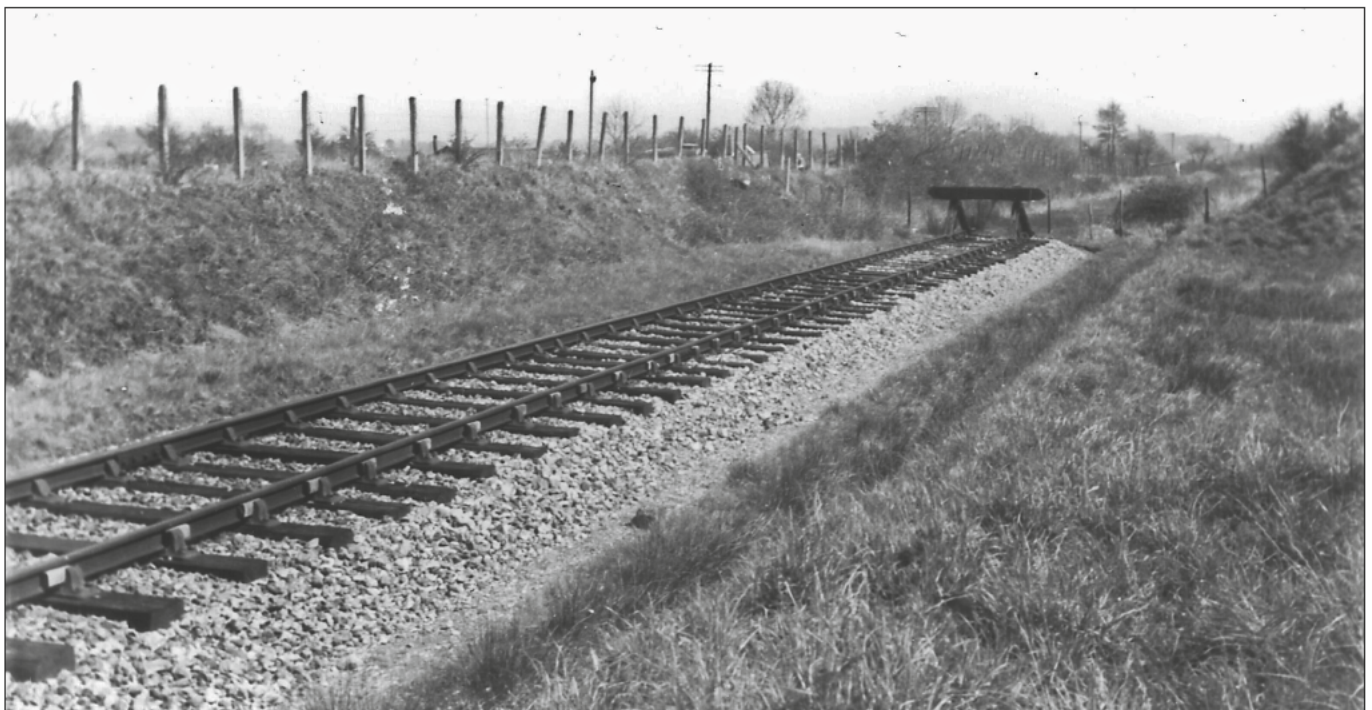
The stub end of the erstwhile Wimborne loop, looking north on 17th April 1949. This formed the headshunt for working Carter's Siding. The loop had been cut back to the buffer stop (61ml 21ch from Bath Junction) in 1933. *Unknown; courtesy R. K. Blencowe Collection, ref 19963.*
