Bridging the Stour at Wimborne‡

Colin Divall

‡ This is a slightly amended version of a paper first published as Colin Divall, 'Bridging the Stour at Wimborne', *South Western Circular* vol.19/2 (April 2022): 61-9. [WV 1.1 Feb. 2023]

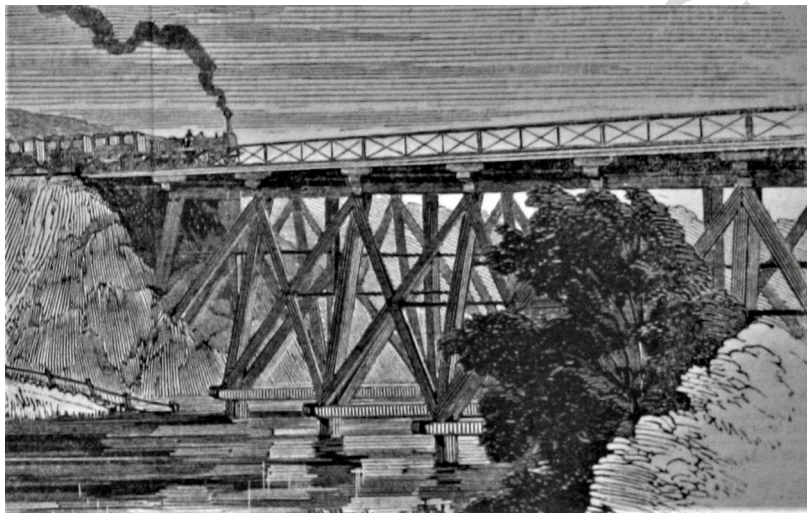
Fig. 1. The Stour viaduct. Extracted from *Illustrated London News* (5 June 1847).

However we have no engineering drawings of the Stour viaduct as built, and evidence from the well-known engraving in the *Illustrated London News* is ambiguous. Although it is important to remember such depictions were never intended to be taken literally, there are good reasons to think that, once allowance is made for the obvious vertical distortion, much of the general scene at Wimborne was fairly accurately drawn.¹⁰ Moreover Dr Nicholas Bill, an expert on early-railway timber structures, thinks the depiction of the viaduct is plausible although he doubts that the riverbed piles would have been vertical – the raking timbers probably continued down into the water, as shown in the earlier, single-track design.¹¹ What then are we to make of the comparison with the ILN's engraving of Peto's earlier structure?

There is an obvious similarity to the fencing. More significantly, the double beams supporting the trackbed at Bricklayers Arms agree with the description Coddington gave for spans of 18 feet or more on the S&D, although this detail cannot be made out with any certainty for the Stour viaduct.¹² All this weighs a little in favour of a design input from Peto, or at least his agent. So too does the fact that some contractors did not have a high opinion of Moorsom; one of his major designs – a timber-lattice bridge over the River Nore on Waterford & Kilkenny Railway (1846) – was reputed to have been found wanting and re-worked by the contractor.¹³ On the other hand it is hard to make out the detail of the internal bracing to the trestles at Wimborne – it *might* be “similar” to that at Bricklayers Arms. And an obvious difference between the two designs lies with the cross-braced timbers between trestles, along with the – presumably iron – lateral tie rods. Coddington made no note of these features, making it harder to be convinced that his Bricklayers Arms reference applied to the Stour viaduct. Of course, it is possible the engraver misinterpreted the sketches from which they were working, although I think that unlikely. On balance I’m persuaded that Peto did have some influence on the design. But we shall probably never know for sure unless contemporary drawings of the design miraculously appear.¹⁴

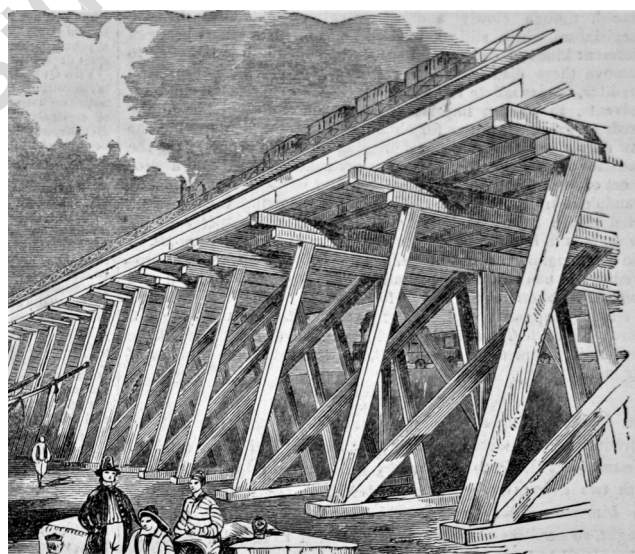
Fig. 2. The Bricklayers Arms viaduct. Extracted from *Illustrated London News* (4 May 1844).

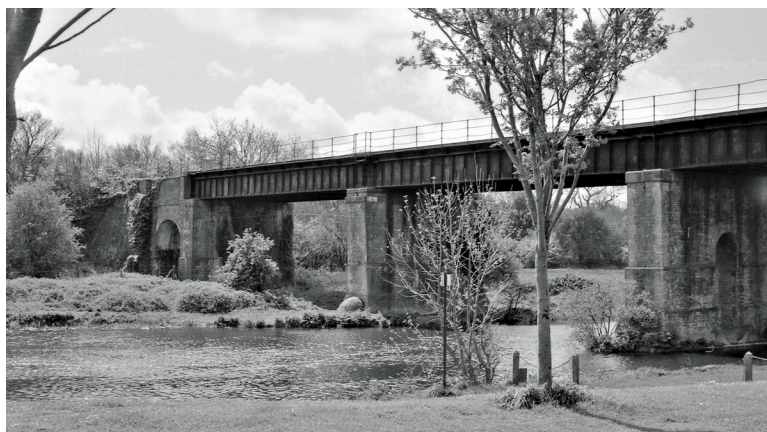
Plate 1. Bridge 76, looking SW towards Poole, April 1977. Photo: C. Divall.

The replacement brick and wrought-iron viaduct – finally designated Bridge 76 by the LSWR – lasted well over a century; until early 1978, having carried its last train in May 1977.

The pattern of land ownership and the width of the surviving embankment, on the Poole side, strongly suggest the replacement must have been built on the same alignment, from underneath. This was common in the mid-19th century. There was no room for the alternative, building alongside.²¹

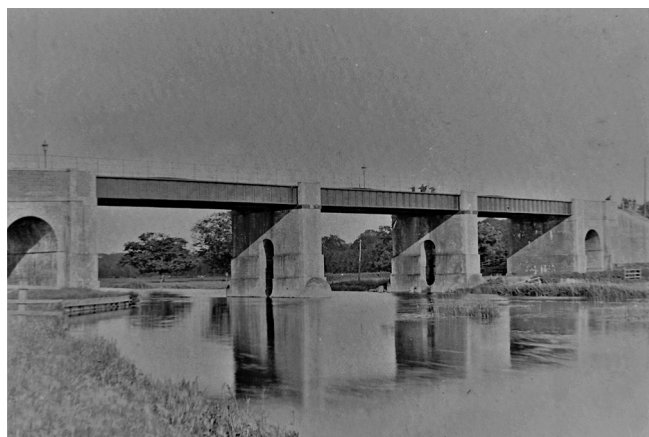
Plate 2. Bridge 76, ca 1892. Photo: E.J. Brett, courtesy Roger Guttridge.

The earliest known image, from about 1892, shows the viaduct probably much as it was some thirty years earlier. Beauty is in the eye the beholder, and this is arguably about as handsome as a plate-girder structure can be: the brick parapets broke up the girders' slab-like appearance. Note too the gas lights – probably mainly for the benefit of shunters, who were forced out along the viaduct when working the down yard.

Removal also made maintaining the bedstones easier, not to mention repainting the iron work. The central girder had already been reinforced by the early 1890s – the top of the arc-shaped ironwork can just be seen in the photograph. It is just possible this was part of the original design.

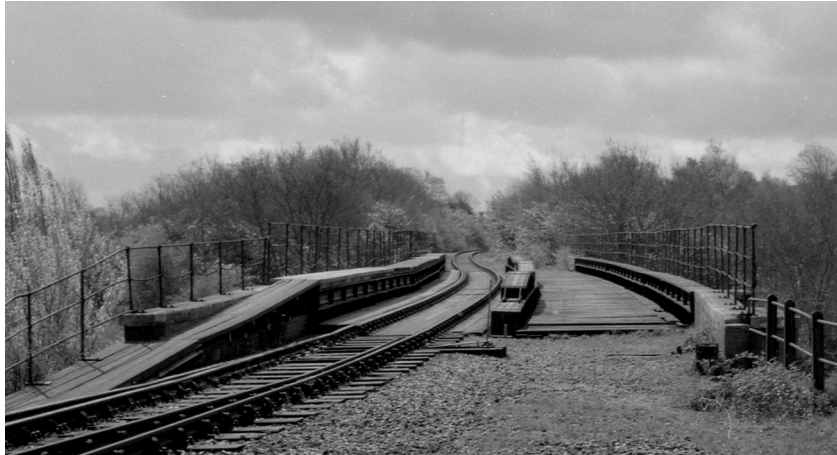
Plate 3. The girder reinforcements, April 1977. Photo: C. Divall.

Assuming the parapets had only been added for aesthetic reasons, they were probably removed once repairs were needed. They certainly had to go when the outer wrought-iron girders were strengthened, as the brickwork would have needed considerable modification to accommodate the substantial beams added to the original metalwork.

The main strengthening took place around 1912 – the well-known Butterley Company of Derbyshire quoted £415 for the metalwork in January that year.²² In the late 1880s and early 1890s the Board of Trade had pushed railway companies to review the safety of older bridges in the light of increasing loadings. But the LSWR's return to the 1891 survey did not note the viaduct as of concern; this is consistent with the photograph.²³ Inspection records for Old Road bridges ca 1909-34 survive, but for the viaduct I only have the data for after 1920. In that year considerable work, including raising girders and repairing bedstones was done to "make good... serious defects".²⁴ Photographs from 1977 suggest that the main work was on the east side of the pier closest to the Poole bank.

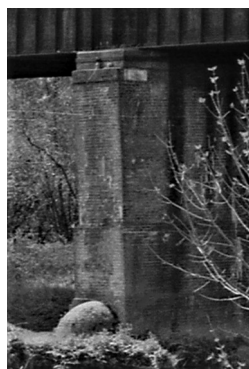
Plate 4. Raised bedstone, April 1977. Photo: C. Divall.

The bedstone on the other side was not built up so it is possible that the foundations had partly subsided, perhaps due to scouring when the river flooded. After these major repairs, only minor maintenance was recorded up to 1934. Even this could be dangerous though; in September 1924, Cyril Herod Cox, a 25-year-old married man from Wimborne working for a Dorchester contractor, drowned when he fell into the Stour from scaffolding while cleaning and painting the ironwork.²⁵

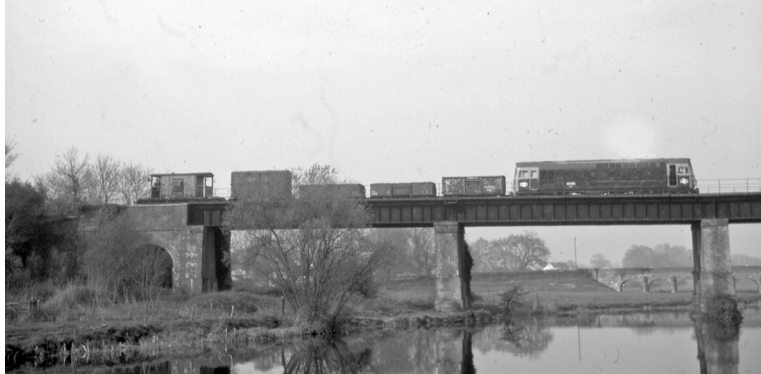
Plate 5. Bridge 76, 10 April 1974. Photo: C. Divall.

The second viaduct lasted for just over a century, although in its last years reduced to a single track. After the Old Road’s closure to passenger trains in May 1964 the viaduct’s up line was taken out of use, on 24 July 1966, and removed shortly afterwards; a slew connected the surviving track across the river with the up line from Broadstone, allowing the rest of the down road to be lifted.²⁹ If the Dorset Central’s deposited plan of 1855 is to be believed, this arrangement echoed that of the previous century – although in the 1850s

the slew was apparently located on the viaduct. The all-timber trackbed makes this plausible.

With just a residual, weekday goods service, plus the occasional working to the exhibition-train depot in Wimborne's down yard, the temptation to cut across the bridge certainly did not lessen. By the early 1970s deterioration of the decking on the disused up side forced BR to lay timbers across the roadbed, further enhancing the unofficial footpath's attractiveness. On the last day of passenger trains, Sunday 1 May 1977, the local population made good use of this 'facility', doubtless unaware that they were standing near the spot where Beckett had lost his life some 86 years before.

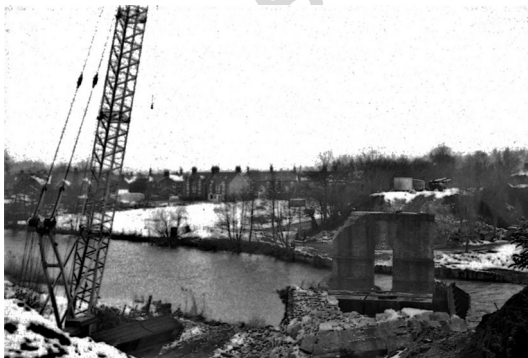
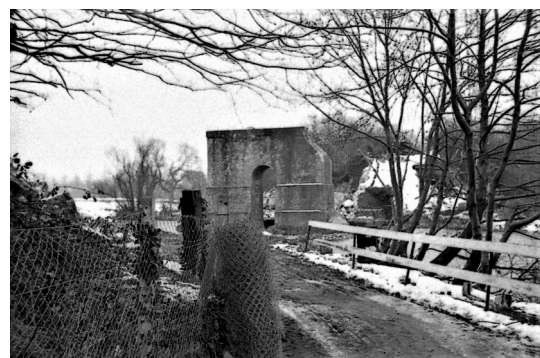
Plates 6 and 7. 18 February 1978. Photos: C. Divall.

Demolition was now more or less inevitable. A last-minute attempt to turn the route south of Wimborne into a heritage operation faced the insurmountable challenge of long-planned major road schemes. BR's view that the viaduct was in poor condition – a judgment challenged by a structural engineer – did not help.³⁰ At a century old, the riveted wrought-iron plate girders were perhaps near the end of their life, although when in 1973-74 BR had reviewed the future of the line north of Wimborne, it had seen no impediment to keeping the line southward open, at least in the short-term.³¹ In any case by the time I returned briefly to Dorset in mid-February 1978, demolition was well under way. A few days later, it was almost completely gone.
