More on doubling the Corfe Mullen cut-off

From Peter Russell

Part 2

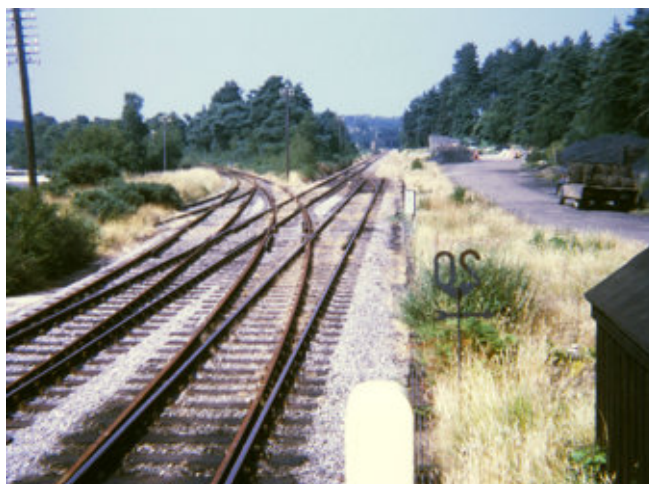
Title photo; Broadstone Junction showing the merging of the two lines into the single line of the cut-off. Photographed in July 1969.

By this time, both lines were in use for limited freight traffic only – the one on the right leading to facilities at Wimborne and West Moors.

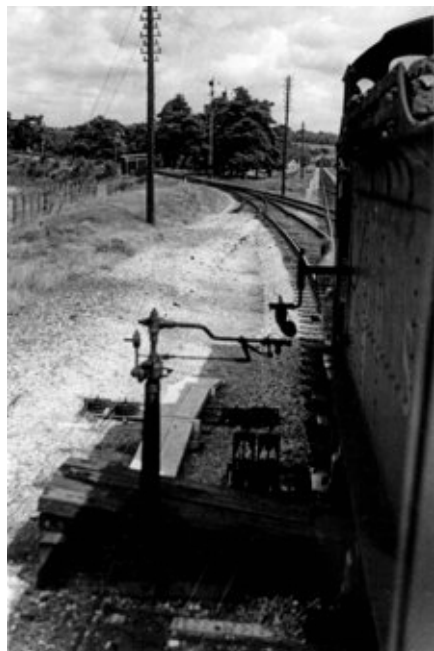
An engine heading for the Corfe Mullen cut-off passes the Whitaker tablet apparatus at Broadstone in August 1950.

Note the siding above the tablet apparatus with a long sand drag.

The year that these two sidings were taken out of use is unknown, but possibly just before – or more likely after – World War 1, as an economy. Both were still shown on the 1926 OS revision (published 1928), but both had gone by the 1934 survey (published 1935), although the connection was still there off the S&DJR, presumably leading to the familiar gravel/ballast drag. A 1920s/1930s photo (reproduced here) shows just a short inward trap point off the S&DJR, leading to a drag of indeterminate length (because it runs out of the picture). It looks like ballast might have simply covered the former siding without shortening the track.

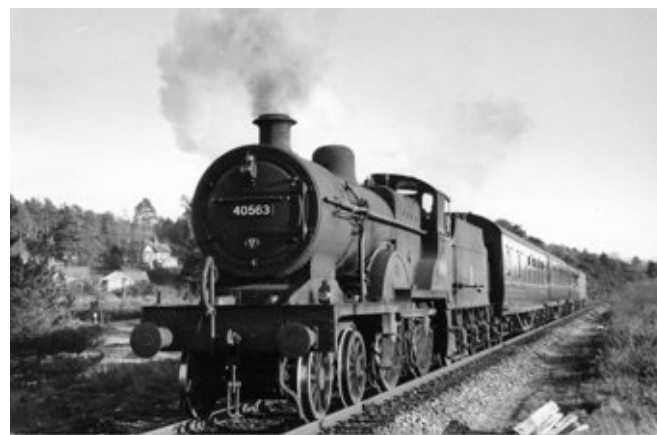
The photo on p.5, showing Bridge 223 at Corfe Mullen (reproduced above), was attributed to John Evers [incorrectly so – Ed.], but was taken circa 1920 by an unknown photographer. John (Jnr.) was most active in the 1960s, and his father, also John, in the 1950s and this picture is an earlier photo included in the South

Western Circle Eyers Collection. After 1905, Bridge 223 was officially known as Corfe Mullen Junction Bridge, but its previous name is unknown – perhaps Blandford Road Bridge, reflecting its carriage of the Poole-Blandford turnpike over the railway.
